# 4 MW Upgrade to DIII-D FWCD System: System Commissioning and Initial Operation\*

## ABSTRACT

Due to various reasons almost every major component in the system required redesign and engineering in order to meet the system requirements. The failures, probable cause and the final redesigns will be discussed as well as some thoughts on how better to specify system requirements for future systems.

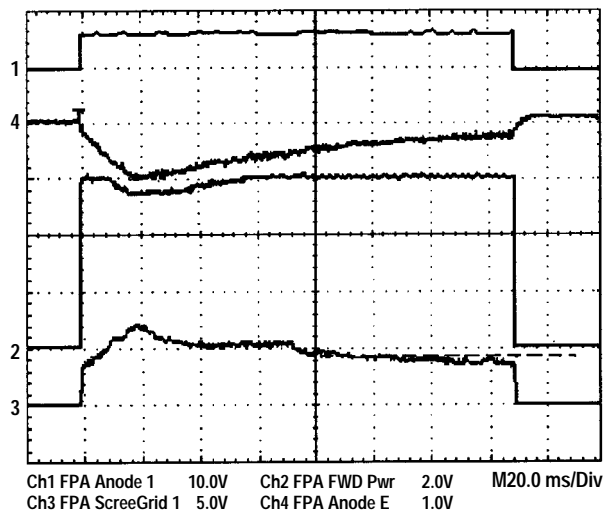
With full power (>2 MW) and long pulses (>3 s) we are starting to see signs of tube problems. There is a gradual increase in anode current after removal of rf drive and there is also a negative screen grid current transient seen at the beginning of this anomaly (Fig. 2). This may be due to secondary heating effects. Owing to lack of a tube vac-ion pump it is not known if there is an increase in tube pressure. The tube manufacturer has been made aware of the problem and we are awaiting their response.

Fig. 2. Anode voltage droop.

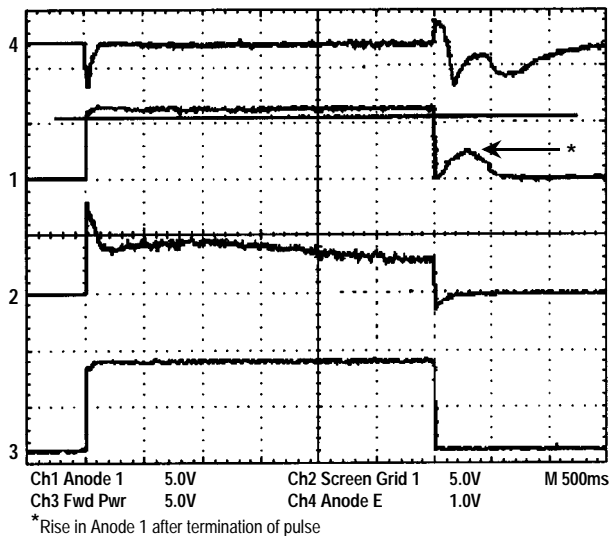
Fig. 3. Secondary emissions.
