RESTORATION OF THE DIII-D SOLENOID

**P.M. ANDERSON, J.I. ROBINSON, E. GONZALES,
and G.W. ROLENS**

NOVEMBER 1997

This is a preprint of a paper to be presented at the 17th IEEE/NPSS Symposium on Fusion Engineering, October 6–11, 1997, San Diego, California and to be published in the *Proceedings*.

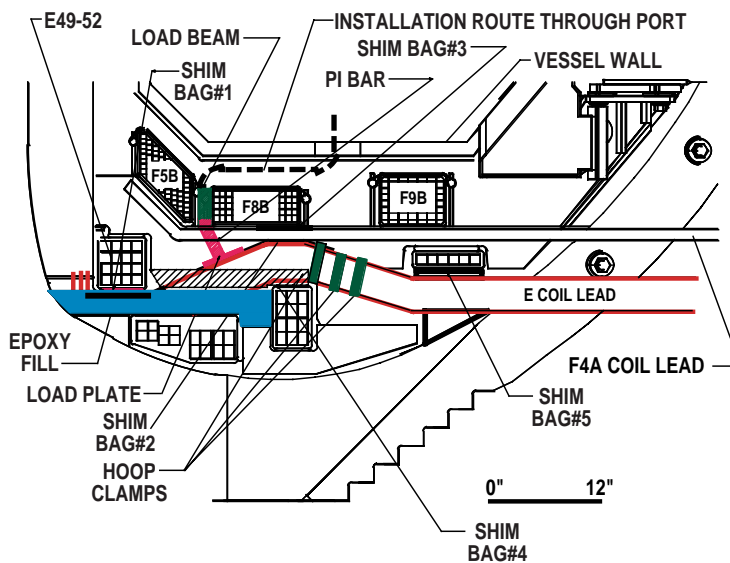
Fig. 1. DIII-D solenoid repair area.

Task 1 was considered to be the most demanding and would be completed successfully before attempting the other tasks. Access through the floor of the vacuum vessel greatly facilitated this task. Fig. 1 shows a vertical cross-section through the lower part of the DIII-D tokamak indicating the solenoid lead, mechanical clamp and bands required for repair.

1. Restrain the conductor pack in the lead area using a clamp to produce 23000 Nt (5200 lb) downward preload against the conductors in the lead. This loading will eliminate cyclic deflections in the conductors which would result in continued crack growth. Actively monitor the preload force to assure proper preload condition. Install three band clamps around the lead between the F5B and F8B coils to maintain the conductors in their proper position since the overwrap has failed in the area between the solenoid and the F9B coil.

The removal of failed shrink tube overwrap from the lead in month four indicated that the tear in the fiberglass structural overwrap extended farther outward than previously known. This extensive failure of the overwrap resulted in the requirement to install three metal strap bands, as shown in Fig. 1, to replace the hoop constraint function of the overwrap. These stainless band clamps were formed in a C shape with a stud and swing bolt on one end and a slotted captive barrel nut on the other end. Like all hardware installed through the vertical port, it was installed one handed with vision provided by two bore scopes with in-vessel and ex-vessel monitors. Designs were evolved to allow reasonable single handed attachment. These band clamps were tightened to develop 10700 Nt (2400 lbs) of hoop tension in each band.

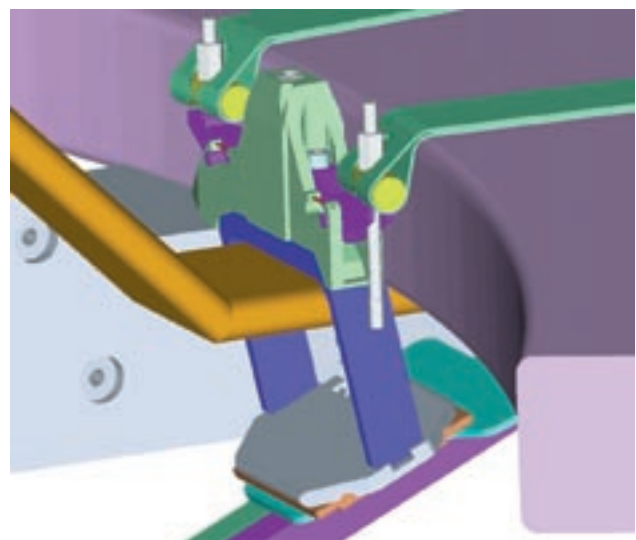
Fig. 2. Solenoid lead clamp system.

The basic mechanical clamp (Figs. 1&2) design was developed based on drawing dimensions. The component parts must be remotely positioned either by long handled tools, strings, or by the arm of a technician reaching through the hole in the vessel floor developed by removal of the vertical port. The clamp applies downward force to a load plate which in turn applies pressure to the inclined solenoid

lead through shimbag #2. Shimbags are positioned and then pressure filled with epoxy and function to distribute the load evenly to the irregular surface of the lead. The outer end of the shimbag is secured to the solenoid lead with one of three hoop clamps. Placement of the shimbag and clamp installation to constrain the shimbag is done first. Installation of the load plate is then done along a horizontal path parallel to the solenoid lead. A 5 m long concentric tubular handle is used to position the plate past its' final insertion position at which time the plate is rotated 90° about two perpendicular axes and then tilted 25° about the third axis in order to align with the surface of the lead. The load plate is then moved outward on top of shimbag #2. The pi bar (a structural bridge that looks like π) is then brought into position through the vertical port opening, and rotated into place straddling the F4A coil lead and engaging mechanical keys into the load plate to prevent slippage between the pi bar and load plate. The load beam is then brought in through the vertical port with the load arms

retracted to allow the beam to be positioned over the pi bar. Deployment strings and threaded fasteners are used to deploy the arms under the existing coil attachment straps which mount the F8B coil to the structural wagon wheel (radial aligned) beams. Once the arms are tightened into place, the clamp load is applied by rotating the jacking screw located at the top of the load beam. Not shown in the figures are the ratchet wrench and push/pull cable system installed over the jacking screw to allow load additions after the vertical port is reinstalled and the vessel is evacuated.

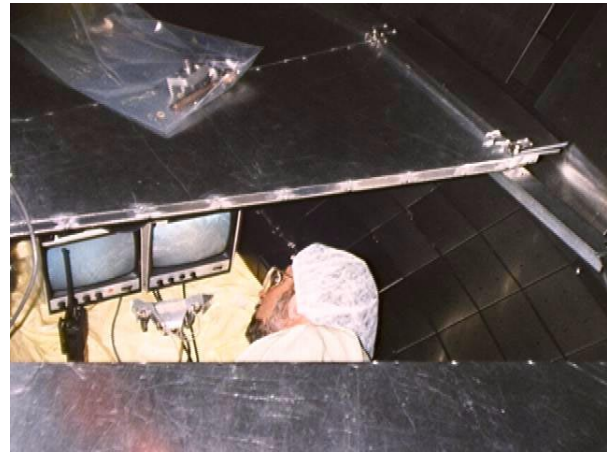
In August 1996, DIII-D was opened for a planned 5 month period for in-vessel installations. The bottom vertical port at 0° toroidal location was cut off from inside the vessel to provide improved access to the failed area of the lead for measurement of as-built dimensional information. Fig. 3 shows the in-vessel technician with his arm extended through the port hole in the floor of the vessel. Two monitors display views for the in-vessel technician from borescopes operated by a technician outside of the vessel.

Fig. 3. Technician operating through port hole in DIII-D.

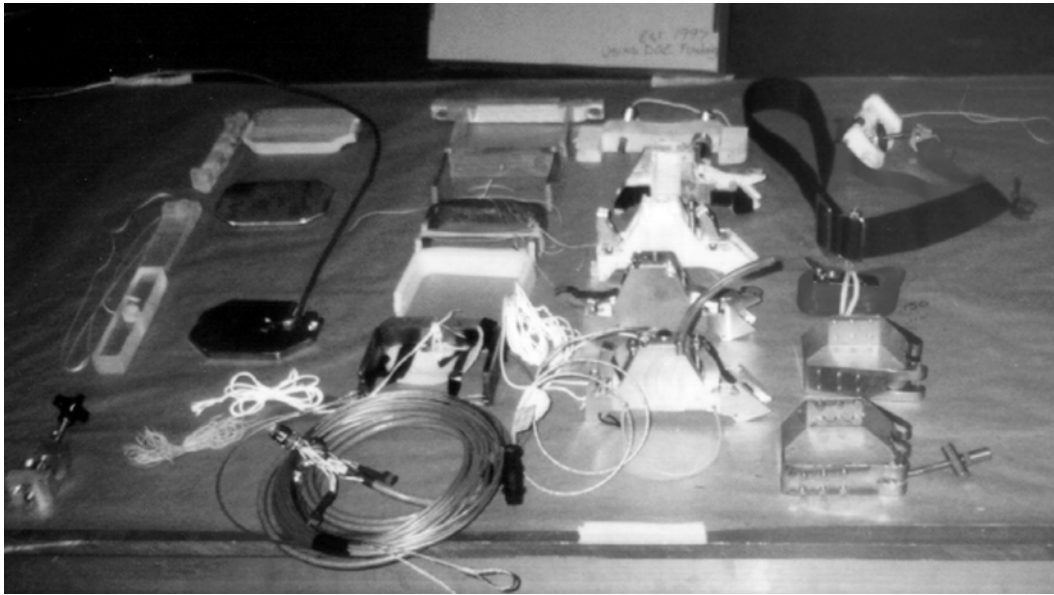
Initial clamp models were made of wood for ease of fabrication and low electrical risk should they become stuck or trapped in place. Prototypes advanced to plastic (Delrin) with aluminum deployable arms constructed to as-built dimensions. Fig. 4 shows the progression of 4 or 5 generations starting at the top of the figure with wooden models and progressing down to production instrumented components of 7075 aluminum and Inconel 718. Inspection gages are on the left of the photo.

Fig. 4. Progression of mockups to production components.

Difficulties occurred in fully deploying the arms on the plastic prototype. The clamp beam was being forced away from the F8B coil due to the equatorial bulge in the overwrap on the coil. This bulge was neither shown on the drawings nor directly measured. The successful trial fit was accomplished by thinning the arms on the prototype. This information was factored into the production design.
