**ANALYSIS AND TESTING OF THE DIII-D OHMIC  
HEATING COIL LEAD REPAIR CLAMP**

by  
**E.E. REIS, P.M. ANDERSON, E. CHIN, and J.I. ROBINSON**

**NOVEMBER 1997**

GA PROJECT 3466  
NOVEMBER 1997

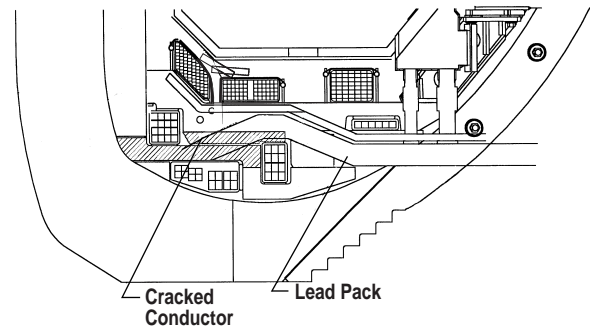
The DIII-D tokamak was designed with two ohmic heating solenoids operating in parallel. One of the solenoids had to be shut down in May, 1995 when a water leak developed in one of the conductors in the lead pack. Inspection of the failed conductor was accomplished using borescopes. The length from the end of the lead pack to the crack location was thereby established. The leak was found to have developed in an area that is highly restricted by major coil systems and structures (Fig. 1). The crack in the copper conductor was seen from inside the coolant hole to extend over a 60 degree arc.

Fig. 1. Location of water leak in restricted area.

The stresses within a properly fabricated lead pack at the cross-section where the leak occurred (Fig. 1) were analyzed using a 2-D plane strain structural model. Minimum material property data for overwrap and wadding were used to simulate a low density of fiberglass that may have been used during fabrication. The maximum stress in the overwrap at its failure location is only 1.1 MPa. The minimum shear fatigue stress for pure resin (no fiberglass is 3.5 MPa at 100,000 cycles and represents a lower bound allowable shear stress. Therefore the lead would not have failed under these assumed conditions.

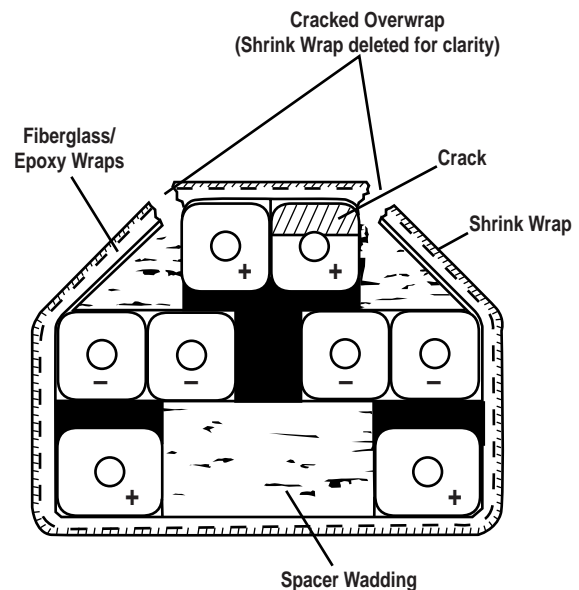
pack. Providing the overwrap remains intact, the stresses in the copper conductor and epoxy overwrap are relatively small compared to allowable values. It was therefore theorized that the overwrap failed, allowing high fatigue bending stresses to develop in the conductors. Special remote handling tools were used to remove the shrink wrap around the lead pack. Borescope inspection showed cracks in the fiberglass overwrap extending over a substantial length of the lead pack. Insertion of the borescope into the lead pack revealed dry fiberglass, confirming the theory that poor impregnation of epoxy during fabrication caused the failure of the top conductor of the lead pack.

Fig. 2. Cross-section of lead pack at location of failure.

The fractures in the fiberglass overwrap at the location of the failed conductor are shown in Fig. 2. These fractures occur at the top of the lead pack and allow the top two conductors to deflect vertically upward and allow bending stresses in the upper conductors to exceed the yield stress of the copper. A fatigue stress analysis of the lead with the upper conductors unsupported over 50 cm was performed using the finite element beam model shown in Fig. 3. A conductor is assumed to be free to deflect vertically upward between the solenoid and the upper conductor bend. The forces within the remainder of the lead pack would result in a downward deflection. However, a G-10 block below the upper bend will prevent downward deflection and is therefore modeled as a simple support at the bend. The peak equivalent alternating fatigue stress occurs at the location of the crack in the conductor which is also the location of maximum deflection (Fig. 3). The fatigue curve for OFHC copper shows that a crack would be expected to start after about 1000 cycles at 200 MPa corresponding to 7.5 Vs operation.

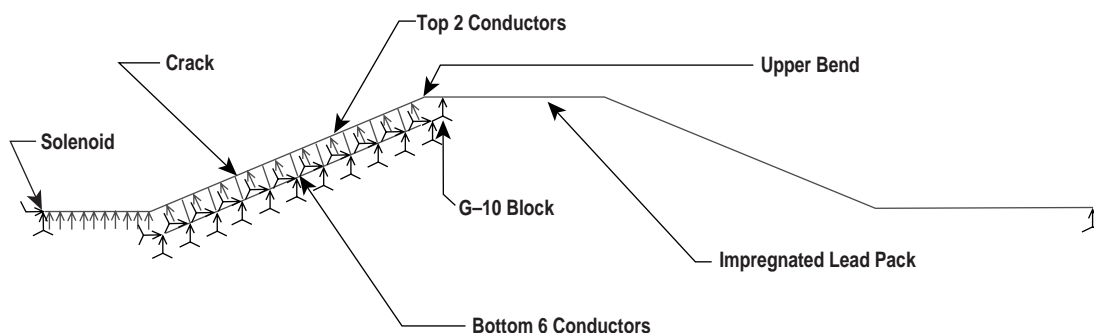
Fig. 3. Structural model for failed lead.

The preload required to assure that stresses at the crack in the failed conductor and the probable crack in the adjacent conductor are always compressive was determined by modifying the boundary conditions to the structural model shown in Fig. 3. The shim bags and blocking reduce the unsupported length of the conductors to a known value of 32.6 cm. The vertical electromagnetic loads on a conductor vary from 494 N/cm at the inner shim bag to 375 N/cm at the upper horizontal section. A vertical preload of 23 kN near the crack location will prevent

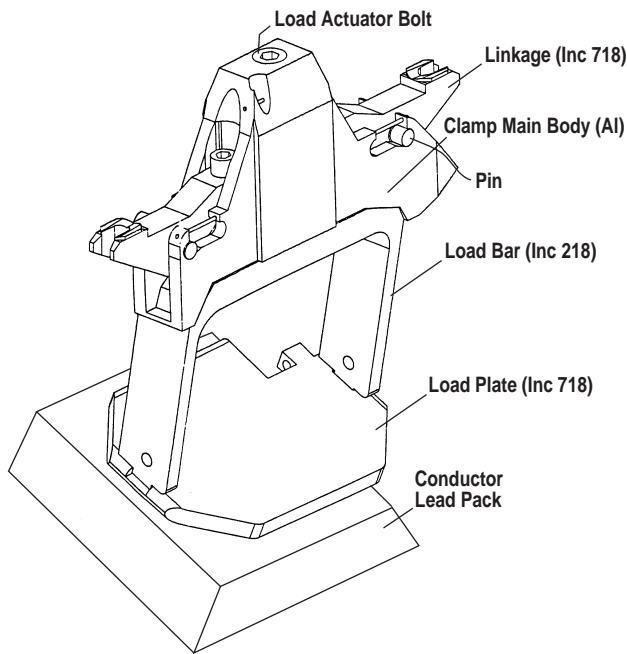
Fig. 4. Isometric of clamp.

The approach taken to repair the failed lead pack utilizes the clamp system shown in Fig. 4 which provides

sufficient preload to the failed lead that cracks in the top two conductors remain in compression under full operating conditions. The load on the clamp assembly was applied by the actuator bolt in the center of the load beam. The load is transmitted through a stack of Belleville washers, then through a 44,500 N load cell and into the load bar. The Belleville washers help maintain the preload after the creep relaxation of shim bags and other epoxy components. The load bar transfers the preload to the load plate, which is mounted over the cracked lead to restrain deflection of the lead under electromagnetic loads. The applied preload was measured by three parallel methods: (1) the calculated load from the applied bolt torque, (2) the load cell output, and (3) the output from strain gages mounted to the load plate.

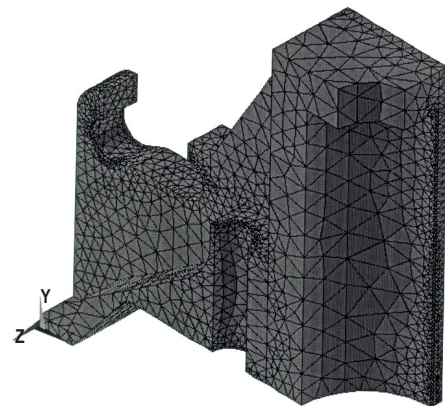
The structural model for the main body of the aluminum clamp is shown in Fig. 5. Symmetry boundary conditions are used to reduce to clamp to a one quarter model. The symmetry condition is approximate since one side of the clamp is slightly longer than the other. Tetrahedral elements with six degrees of freedom per node were used in the model. Due to the limited space available, the aerospace criteria of using the allowable bending stresses equal to the material yield stress (510 MPa) was adopted for design of the main body of the repair clamp. The 7075-T6 aluminum has a minimum elongation to failure of eight percent.

Fig. 5. FE model of clamp.
