**FABRICATION OF NEW MAGNET
POLE SHIELDS FOR THE 80 KEV
NEUTRAL BEAM LINES FOR DIII-D**

This is a preprint of a paper to be presented at the
21st IEEE/NPSS Symposium on Fusion Engineering
2005, Knoxville, TN, September 26-29, 2005 and to be
printed in the *Proceedings*.

GENERAL ATOMICS PROJECT 30212
OCTOBER 2005

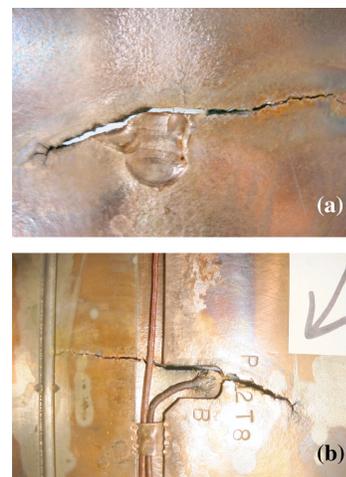
In September 2003, during DIII-D physics experiments involving C-coil currents approaching 7 kA, a water leak was detected inside the 30-deg neutral beam line that terminated operations. The ensuing investigation determined that the leak was in the water cooling line imbedded in the right bending magnet pole shield serving the left 30-deg ion source. Both the right and left pole shields for this ion source were subsequently removed from the line, and inspection determined that the leak was caused by an abnormally high heat load near the center of the beam side of the pole shield. The high heat load caused severe material damage and local melting of the copper shield [Fig. 1(a)], which initiated a through-wall crack that propagated bi-directionally to a length of 4.13 in. (105 mm) until one crack front broke through the shield's brazed, imbedded stainless steel cooling tube [Fig. 1(b)]. Furthermore, the left pole shield was also found to be damaged in a similar fashion in the same location, but its through-wall crack had only propagated to a length of 2 in. (50 mm), its crack front not yet reaching the cooling tube. The damage zone, marked by a severe orange-

peel texture, on the beam-side surface of both shields was in an arc-shape, generally coinciding with the location and shape of the magnetically bent, charged particle beam adjacent to the pole shields during neutral beam operation. Beam impingement was thus suspected to be the cause of damage, and an inspection survey was conducted to determine the condition of the remaining 14 pole shields in DIII-D's four neutral beam lines. The survey determined that damage of the same type and location was present in nine additional shields, with surface melting evident on five shields and cracks present also in six shields. No damage was found in five shields.

Figure 1. The 4.13 in. 105 mm) through-wall crack in the right pole shield of the 30-deg left neutral beam line, as seen from (a) the beam side, and (b) the thermocouple side. Melting and severe surface damage can be seen accompanying the crack in (a), while crack propagation to the brazed cooling tube can see on the left in (b).

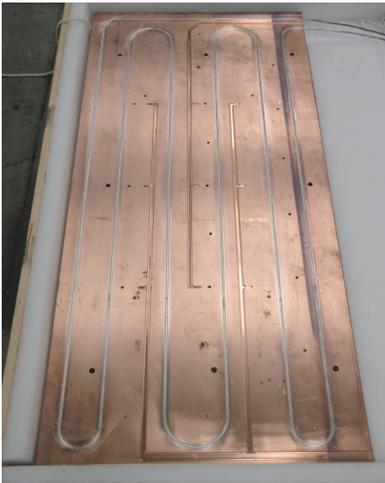
Figure 2. A newly fabricated pole shield is shown after successful brazing of the imbedded stainless steel cooling tube. Thermocouples have not yet been installed.

The vacuum brazing of the tubes into the shield plates was successfully accomplished. No voiding was seen along the braze interface of any tube, and more than ample tube surface area was covered by braze metal for heat transfer purposes.

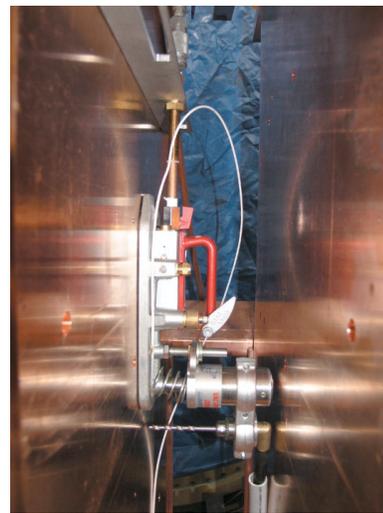
Figure 3. The crack tip hole-drilling apparatus is shown installed between the pole shields of a neutral beam line. The drill and air cylinder actuator is seen at the bottom; the device is positioned from a temporary support (top) before the suction mount is actuated.

A support bracket with long slots and fastener holes was machined from a piece of aluminum angle. This bracket was attached to existing holes in the pole shields above the cracks. A copper tube, externally threaded a majority of its length, was added to the air inlet port of the drilling device. Two jacking nuts were threaded onto the copper tube before a quick-disconnect air line fitting was added to the end of the tube. The drilling device was then suspended from the fixed bracket by inserting the copper air tube through one of the slots in the bracket, with a jacking screw above and below the bracket (Fig. 3). Horizontal position of the drilling device was then adjusted by sliding the copper tube side to side within the slot in the support bracket, while vertical position was adjusted by turning the jacking screws on the threaded copper tube. A hand-held mirror or borescope was used to locate the crack tip as the drilling device was being positioned. The drill bit feed was controlled by a finger-actuated trigger on the device. All crack tips were drilled using a 0.25 in. diam bit, the largest size that could be made to work properly.

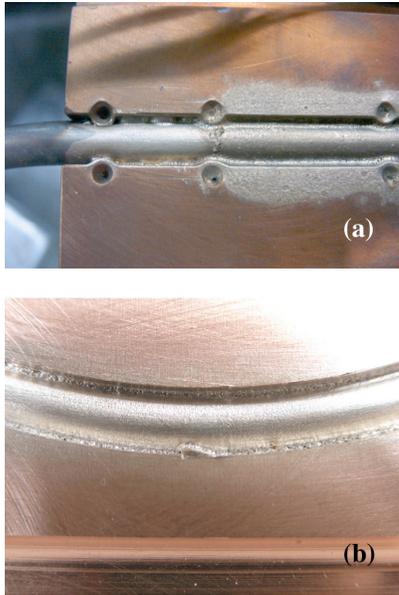
Numerous difficulties were encountered when the pole shields were originally fabricated in 1984-85. OFHC copper is so soft after annealing, a required step, that any handling of the plates after this point of the fabrication process often led to gross plastic deformation of the plate. The use of coiled copper refrigerator tubing was originally attempted but the tubing could not be made to lie perfectly flat within the machined grooves in the plates, which compromised the quality of the braze, and the dissimilar metal connections between the copper tubing and the stainless steel water supply lines inside the neutral beam lines leaked frequently. The tubing specification was then changed to type 304 stainless steel, seamless, 0.25 in. (6.3 mm) diam by 0.020 in. (0.5 mm wall) by 35 ft (10.7 m) long. Cleanliness of the plate and tubing had to be maintained stringently or else the pump down portion of the vacuum braze run would be prohibitively long. Staking the tubes in their machined grooves became essential as the tubing would otherwise float on the braze metal as it liquefied. The original tube staking was done with center punches but the punches would occasionally slip and puncture the tubing. Securing the thermocouple leads also became problematic in that the stainless steel sheet metal clips that were staked over the top of the leads in their grooves occasionally severed a lead wire as it was trapped in the bottom corner of its groove under the edge of the clip. Possibly the greatest problem, however, was the difficulty in fitting the serpentine-shaped tubes fabricated by a vendor specializing in tube bending into the mating groove in the pole shield machined by a vendor specializing in computer-controlled milling. Mismatches as small as a few thousandths of an inch in the geometries of the tubing and the grooves would cause the tubing to buckle out of its groove, making it extremely difficult, if not impossible, to stake properly into the plate.

Figure 4. The old (a) and new (b) methods of staking the stainless steel cooling tube into its groove is shown. The old method used a hand-held center punch while the new method employed a CNC head-mounted crescent-shaped cutter.

The nickel-plated tubes were staked into the annealed copper shields using a new method. Rather than hand-staking the copper using a center punch to deform the walls of the groove around the tube, a staking tool was designed that shaved a thin strip of copper from the wall of the groove and bent it against the top side of the tube. Fig. 4 shows the results of the old and new staking methods. The new staking tool, designed to be held by the CNC mill that machined the shield plates, has a cutting end shaped like a crescent, with the ends of the crescent being the cutters and the distance between the cutters being slightly greater than the diameter of the tube. In the staking procedure, the CNC mill head, holding the staking tool, tracks along the centerline of the tube using the geometry from the original database, then pushes the staking tool down into the copper plate every 4 to 6 in. (100 to 150 mm), cutting and bending thin shavings over the top half of the tube. Since the cutters are never directly over the tube at any time, the risk of puncturing the tube is eliminated.

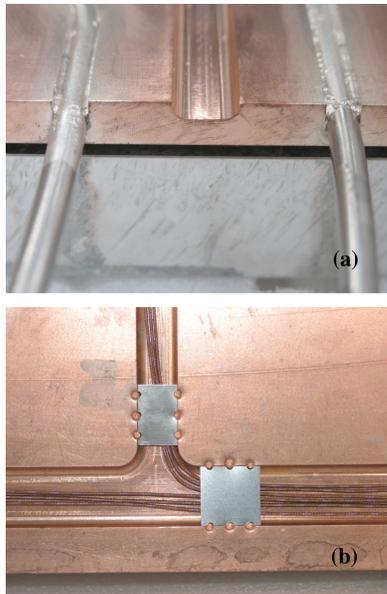
Figure 5. The profile of the thermocouple grooves were modified to reduce the stress concentration in their corners. The new groove corners are fully radiused (a), and the staked thermocouple lead clips (b) can no longer pinch or sever the leads.

Modifications were also made to the shape of the thermocouple grooves machined in the pole shields. Under severe, thermally induced stress, cracks had initiated in the pole shields at the stress concentration formed at the sharp bottom corners of the thermocouple grooves. In the new pole shields the bottom corners of all thermocouple grooves were fully radiused [Fig. 5(a)]. With no corners in the thermocouple grooves in which to pin a thermocouple lead, the risk of pinching and severing a thermocouple lead with a staked clip was eliminated [Fig 5(b)]. Recesses machined into the edges of the stainless steel clips prevented the clips from buckling as the staked copper deformed against the edges of the clips.

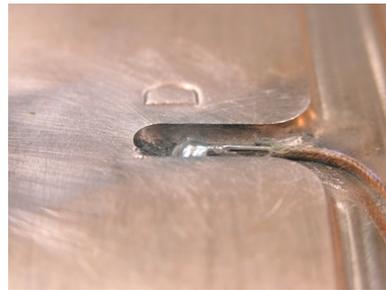
Figure 6. The thermocouple junctions are attached to the back of the pole shields using a gas tungsten arc welding process. The filler metal is a silver-copper-phosphorus alloy.

Thermocouple junctions were attached to the pole shields using the gas tungsten arc welding process. AWS BCuP-5, a silver-copper-phosphorus alloy, was used in stick form to deposit a molten metal bead onto the copper shield plate into which the thermocouple junction was inserted. Solidification of the bead fixed the thermocouple junction to the plate. Fig. 6 shows a thermocouple welded to a shield plate in the narrower, fully radiused thermocouple groove of the new design.
