GA-A26751

**COLLATERAL EFFECTS OF THERMO-OXIDATION ON
DIII-D IN-VESSEL COMPONENTS AND FIRST RESULTS
FROM THE IN SITU OXIDATION IN DIII-D**

JULY 2010

**GENERAL ATOMICS PROJECT 30200
JULY 2010**

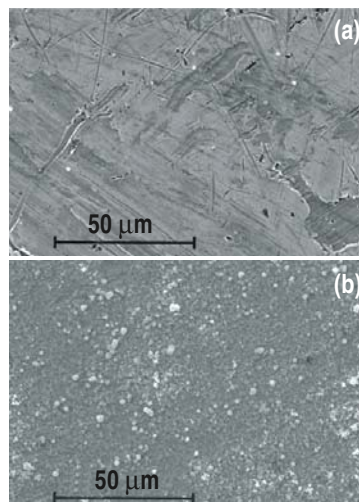
Most components were unaffected by oxidation in air, as was also the case with pure oxygen [14] (Sec. III.A). The exceptions were Cu components, which developed CuO layers of varying thickness (up to 1 μm) (Sec. III.B and Table II). SEM photos of a Cu gasket, before and after oxidation, are shown in Fig. 1. The oxidation of Cu was determined to be manageable: for many surfaces, the presence of CuO was of no concern since the oxide layer did not flake. For the ECH mirrors, pulsing of radio-frequency power was expected to clean the surfaces, but these mirrors were scheduled for replacement in DIII-D regardless. The ICH antenna was scheduled for removal and plating with nickel; the formation of the oxide layer merely adds a “cleaning” step to that process (Sec. III.B).

Fig. 1. *Ex situ* experiment in the LLNL chamber at GA: SEM pre-oxidation (a) and post-oxidation (b) photos of Cu gasket.

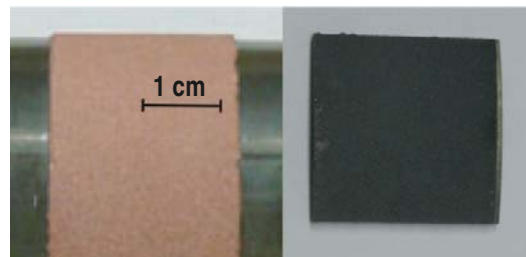
Cryopump Shield Coating. Under oxidation, the surface of a Metco 55 copper *flamespray* coating on Inconel™ turned dark grey, but the oxide layer did not flake, even with friction (Fig. 2). When examined under an optical microscope, the surface appeared as an aggregate of small, smooth spheres, ~0.1 mm in diameter. This result is consistent with those for polished copper surfaces (e.g., the ECH mirror), which were found to oxidize less than unpolished copper surfaces.

Fig. 2. METCO55 cryopump shield flamespray specimen subjected to *ex situ* oxidation in the LLNL chamber at GA: pre-oxidation (left), post-oxidation (right). Copper portion has turned dark grey. Post-oxidation specimen was cut from larger specimen on left.

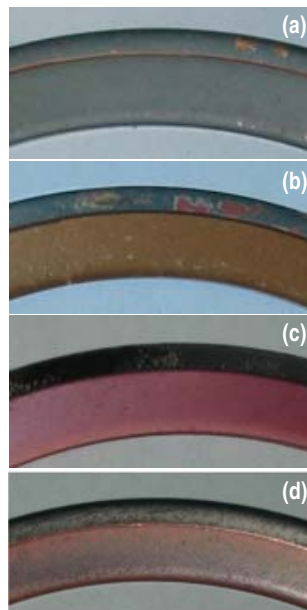
The University of Toronto collateral effects experiments were performed in a chamber which has previously been extensively used for studies of oxidative removal of carbon codeposits from tokamak tile specimens. Consequently, C impurities had already been deposited on the chamber walls. The first set of collateral experiments performed in this chamber showed evidence of enhanced oxidation on a Cu gasket [14] [Fig. 3(a)]. The Cu oxidation experiments were then repeated in a brand new SS chamber with no prior C exposure and the results showed only minimal evidence of oxidation, with minimal colour change. To test the hypothesis that carbon promotes the oxidation of copper, the C-contaminated chamber was cleaned by etching the SS walls with 30% HCl solution. In the experiment that followed, the copper gasket oxidized only minimally [Fig. 3(b)]. Subsequent oxidations of carbon tiles resulted in copper again oxidizing heavily, changing colour to red-grey [Figs. 3(c) and 3(d)].

Fig. 3. *Ex situ* experiment at U. Toronto demonstrates that exposure to carbon influences severity of copper oxidation. (a) Copper gasket oxidized in chamber previously baked with carbon many times. (b) Gasket oxidized in cleaned system (walls etched with 30% HCl). (c) Gasket oxidized in system with carbon-deposited specimen. (d) Gasket oxidized in system with co-deposited CFC tile.

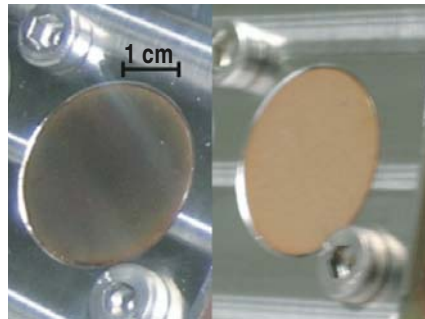
Copper material specimens mounted in DIII-D showed modest oxidation less severe than in *ex situ* experiments. Visual inspection of a copper mirror specimen did not indicate darkening, as had been observed in *ex situ* experiments, although the mirror appeared qualitatively to be less reflective (Fig. 4). A mini copper gasket darkened slightly (Fig. 5), but did not turn gray as expected from *ex situ* experiments. A METCO55 (99% Cu flamespray) coupon, similar to the coating used on the cryopump shield, also darkened less severely than expected. The reduced severity of the oxidation may be due to the consumption of oxygen during the experiment, which reduced the partial pressure of oxygen available as compared to the *ex situ* tests.

Fig. 4. Copper mirror specimens inserted in DIII-D during *in situ* oxidation: pre-oxidation (left), post-oxidation (right). The mirror is similar in colour, but qualitatively appears to be less reflective after oxidation.

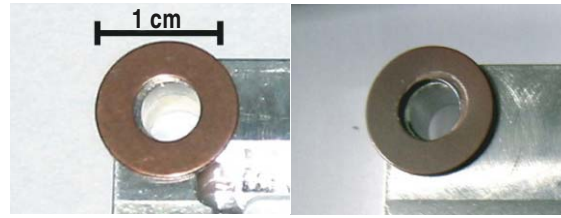
Fig. 5. Copper gasket inserted in DIII-D during *in situ* oxidation: pre-oxidation (left), post-oxidation (right). The copper has darkened slightly by oxidation.
