**STRUCTURAL UPGRADE OF IN-VESSEL
CONTROL COIL ON DIII-D**

P.M. ANDERSON, A.G. KELLMAN, E.E. REIS

AUGUST 2004

GENERAL ATOMICS PROJECT 30200
AUGUST 2004

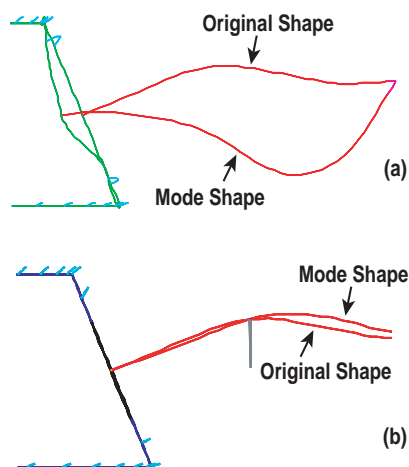
The horizontal cracks were consistent with the theory of resonant vertical vibration of the coaxial section of the I-coil leads inside the port. Analysis and testing of the prototype coils had neglected deflection monitoring of the leads since the coaxial design assured no net $I \times B$ forces. Earlier tests emphasized the single conductor portion of the coil since $I \times B$ forces were clearly present and significant. The single conductor coil sheath is attached rigidly to the vessel every 15 cm as seen in Fig. 2. The single conductor far away from the coaxial lead had been instrumented with field compensated strain gages during in-air $I \times B$ testing of the prototypes including I-coil frequency sweeps. The strain gage signals had not indicated any resonances to 1000 Hz. All prototype testing was done in the N=1 configuration.

Initial FEA modeling of the vessel port, coaxial lead and vertical conductors of the coil, as shown in Fig. 4(a), predicted a vertical mode of the lead at 125 Hz. This model is constructed from a number of elements with a combined stiffness that includes the copper, polyamide and stainless steel and a combined mass that includes those materials plus cooling water. The ex-vessel portion of the coaxial lead and its transition into quadrupole cabling was not modeled. At resonance, theoretical system deflection of an ideal spring-mass system is limited only by damping. Early modeling was done with 2% damping but cantilever beam decay testing indicated 4% damping. After the vessel was opened for in-vessel work, dynamic testing of the leads at this port (180R+1) indicated a first natural frequency of 110 Hz based on accelerometer output. The FEA model was updated to include the repair elements and is shown in Fig. 4(b).

Fig. 4. Mode shapes of 180R+1 I-coil lead at first vertical resonance for (a) 2002 installation and (b) 2004 with vertical stiffness and mid-length support. The calculated vertical deflection at resonance has been reduced from (a) 8 mm at 110 Hz to (b) 0.5 mm at 365 Hz.

During the modification of the coil leads, natural frequency of each type of lead was measured at each repair step in order to tune the FEA model to the measured frequencies. This measurement was made by impacting the lead and monitoring the response from an accelerometer mounted on the coax lead. The addition of both the vertical split sleeves and the lead stabilizer increased the measured natural frequency of the failed I-coil from 110 to 365 Hz.

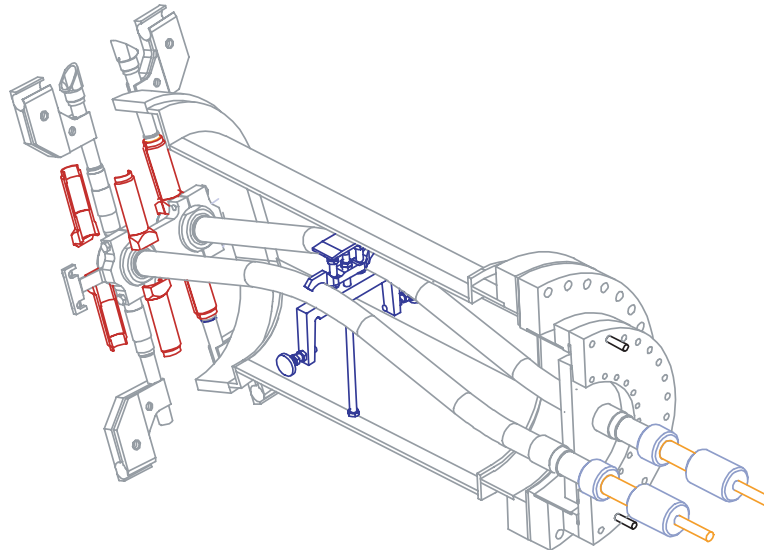
Subsequent inspection of the leaking coil, aided by a magnifying glass, detected a horizontal crack across the inward facing surface of the upper 19 mm transition sleeve near its attachment to the stiff 63 mm diameter coaxial assembly. The neighbor coil in the same port was also found to have a crack indication but no leak. This failed set of coil leads were the longest used in the I-coil system and have a common, relatively low, first natural frequency. No cracks were seen in the other 10 coils.

Fig. 5. Split sleeve and lead stabilization hardware installed to repair failed I-coil at 180R+1 port. Blue parts are the mid-length lead support. Red parts are the split sleeve assemblies to seal the leak and increase stiffness.

Since there was no detectable damage to the I-coil electrical insulation, in-situ repair of the cracked coil was planned. Three different styles of coaxial leads are shown in Fig. 1. FEA modeling of the failed lead indicated that the coaxial conductor must have flexed about ± 9 mm vertically at its mid-length in order to develop a crack within 100 cycles. The required force to develop this deflection could be produced in the unsupported sections of the single conductor at the vessel ports if the driving force were at the resonance of the coaxial lead. A mid-length location on the lead was chosen for the installation of a support to form a vibration node and significantly increase the first natural frequency of the lead at the 180R+1 port location. This added support is shown in Figs. 5 and 6. A split sleeve, also shown in Figs. 5 and 6, was welded in place over both single conductors for this coil to seal the leak and to smooth the stiffness change from the coax to the single conductor. The two other upper ports at toroidal locations of 60° and 300° have shorter, straight coaxial leads with a fundamental vertical frequency around 300 Hz which was considered to be acceptably high and, therefore, required no mid-length support. These coils were also modified with single conductor stiffeners at the connection to the coaxial lead. The three sets of coils on the lower half of the tokamak have identical feeds at 60° , 180° , and 300° . These leads are of intermediate length with a single bend and required both a mid-length support and single conductor stiffeners at the connection to the coaxial lead.

The construction of the coil starting from the outside is generally 0.8 mm thick stainless steel tube wall, 1.5 mm thick polyamide insulation and 14 mm diameter hollow copper conductor. Welding directly on the stainless overheats and chars the polyamide. The coil has specific areas designed for welding and the split sleeves were circumferentially welded in this area. The seam welds between the halves did not contact the underlying stainless and heating was not an issue. Welding directly to the stainless cylinder at the transition of the single coil conductor to coaxial feed is allowed due to the thick wall construction of the cylinder. Practice welds were developed on sample parts attached to a vacuum vessel wall mockup in order to assure welder access. A mechanical loading device measured the radial stiffness of the original and reinforced vertical conductors in the mockup. The stiffness increase was about 250%. This measured stiffness was used in the FEA for natural frequency determination. It was also used in analysis to assure acceptable compliance of the system during vessel baking.

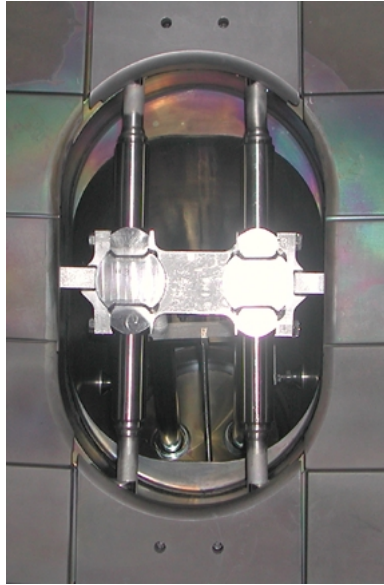
Fig. 6. Repaired I-coils at 180R+1 port.

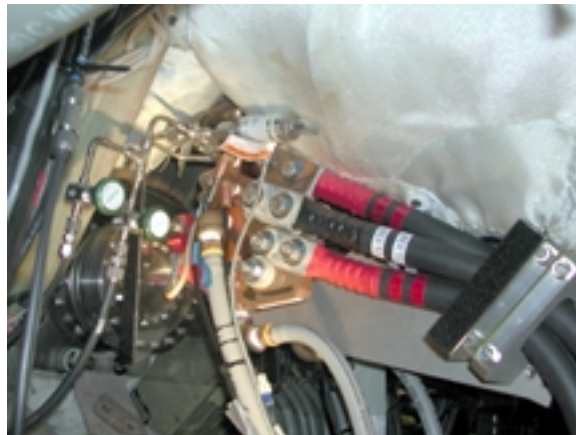
The lower six I-coil leads exit the vessel through three identical vacuum pumping ports that were modified in place (2002) to allow the leads to exit through the floor of these ports. The transition from coax to quadrupole cabling for these coils is located in a lower TF region than the corresponding upper coils and they therefore experience lower $I \times B$ forces. However, the structural support of the transition region for the lower coils is inherently less robust than the upper coils due to spatial constraints shown in Fig. 7. The footprint of the structural support bolted to the modified port, which is not visible in Fig. 7, is relatively small. The port deflection sensor, that is mounted to the bolted structure, displays nonsymmetrical deflections indicating that the preload in one of two attachment bolts is being exceeded and causing a gap to form in the joint during vertical vibrations of the lead.

Fig. 7. Electrical power and fluid connections to a pair of lower I-coils. The transition between coaxial lead and quadrupoled power cable produces some uncancelled $I \times B$ forces.

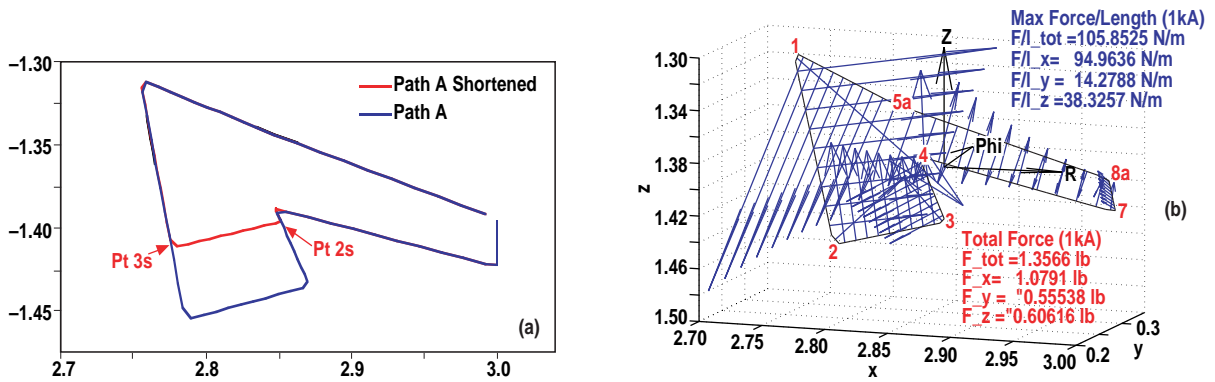
A detailed analysis [3] of the $I \times B$ forces was performed for this transition area to determine the forces generated by the unbalanced current path. Figure 8 shows the magnetic field from the TF coil set. Analysis was also done for the poloidal coil magnetic field that produces lower forces than the TF. Forces were calculated for the points along the unbalanced I-coil current flowing in the copper plate that connects the inner coax conductor to the power cables. This path is shown in Fig. 9(a) along with a proposed modification to the path. These forces are shown for one coil in Fig. 9(b) for a 7 kA I-coil current and a 2.2 T TF, sum to 28 nt toroidally and 58 nt in the radial-vertical plane that contributes to flange liftoff. The net force applied to the port, depending on the N=1 or N=3 connection, is either combined with or nearly cancels those produced in the neighbor coil lead transition.

Fig. 9. (a) Path of unbalanced I-coil current in copper transition plate for lower coils. The red line indicates a path reduction of replacement part to reduce $I \times B$ forces by 30%. (b) Force generated in copper transition plate due to $I \times B$.

By redesigning the copper plate to the alternate path shown in Fig. 9(a), these forces are reduced by 30%.

An upgrade is scheduled for installation in September 2004 to (1) reduce the applied loads due to unbalanced currents by 30% to the lower port leads by redesign of the copper bus plate, and (2) increase the natural frequency of the I-coil lead supports for the lower ports and improve the attachment fasteners to prevent flange liftoff. This upgrade is expected to allow unrestricted operation of the I-coils throughout the design range of 7 kA, 0 to 1000 Hz.
