**CORROSION SCREENING OF
CONSTRUCTION MATERIALS
FOR HYDROGEN IODIDE DECOMPOSITION
HEAT EXCHANGER FABRICATION**

**Milestone Completion Report
(January 2004 through June 2005)**

B. WONG, L.C. BROWN, and G.E. BESENBRUCH

**GENERAL ATOMICS PROJECT 30231
DATE PUBLISHED: JULY 2005**

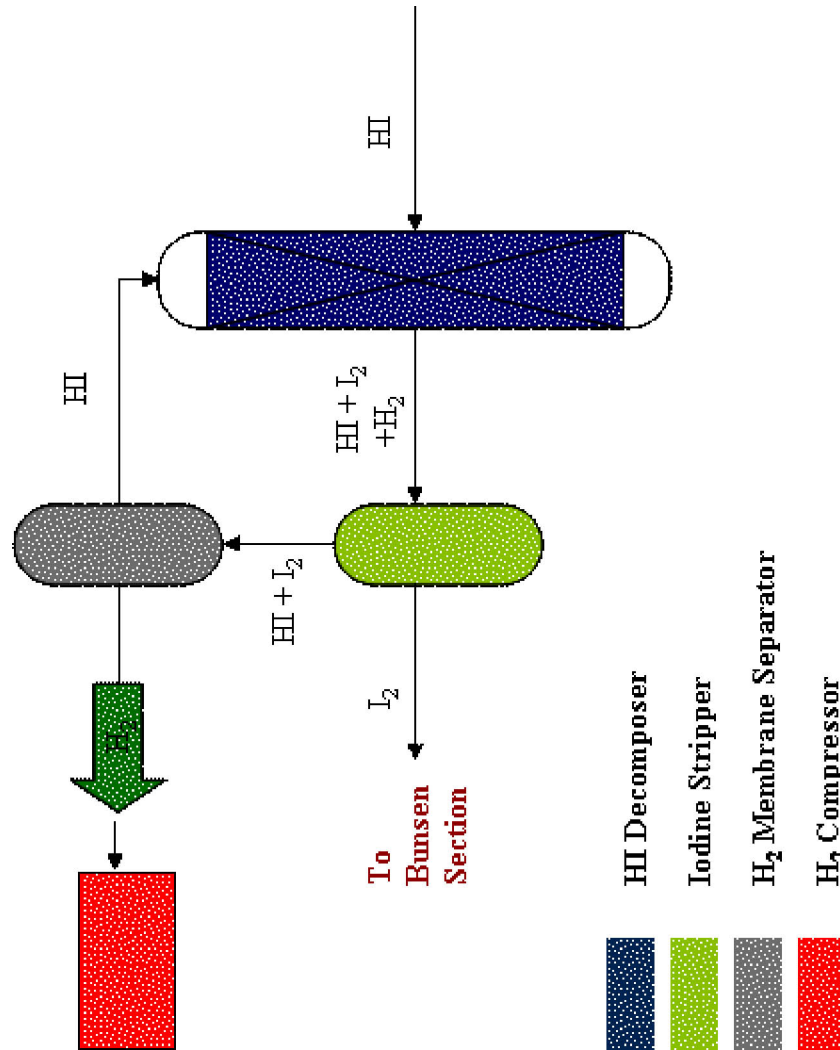
Fig. 3. (b) HI extractive distillation flowsheet — HI decomposition.

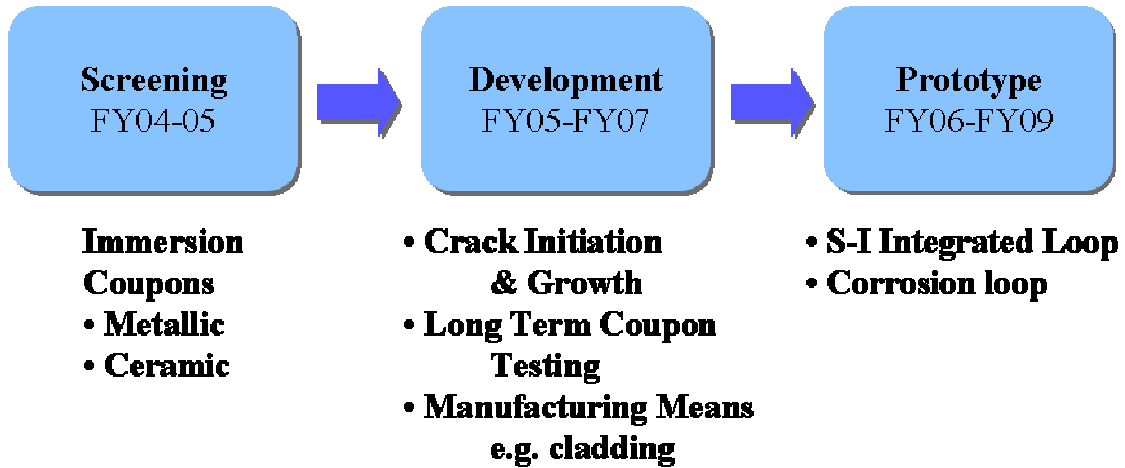
Fig. 4. Plan to identify construction material for HI decomposition heat exchanger.

In the final phase of this program, prototype components built from qualified construction materials will be tested in a corrosion loop with cycling chemicals. This provides an opportunity to assess the long term performance of manufactured components and evaluate new fabrication and design techniques such as cladding and lining.

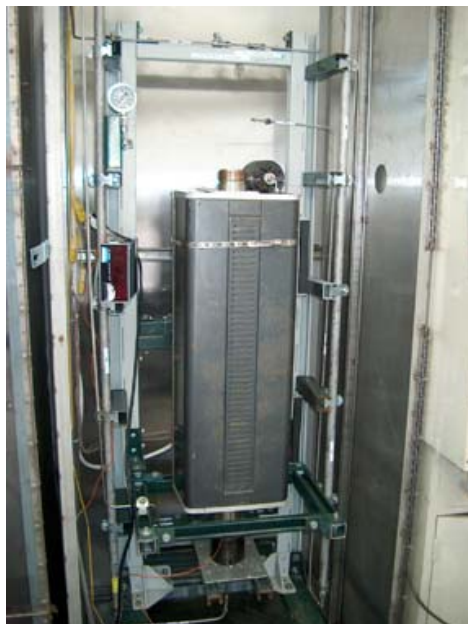
Fig. 6. Test apparatus set up with the pressure vessel tube sitting inside the tube furnace.

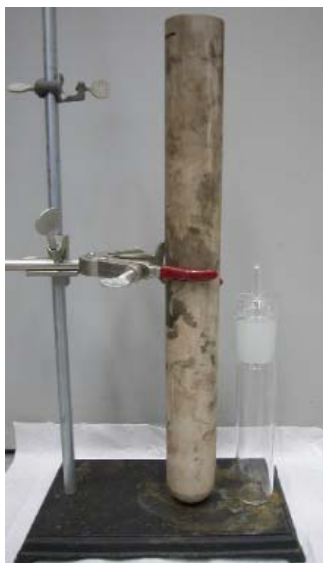
Fig. 9. Mullite tube in which the test cell is located.

The mullite tube is placed inside the pressure vessel and sits on top of a basket of activated charcoal. This charcoal basket is located below the high temperature zone. The cooler temperature improves the charcoal's efficiency to absorb HI and I_2 . The free space inside the vessel is filled with steel wool to catch and react with any HI_x vapor. This cuts down the reaction between the vapor with the vessel wall. In the larger test system, a thermal couple is placed next to the glass capsule to provide instant temperature feedback.

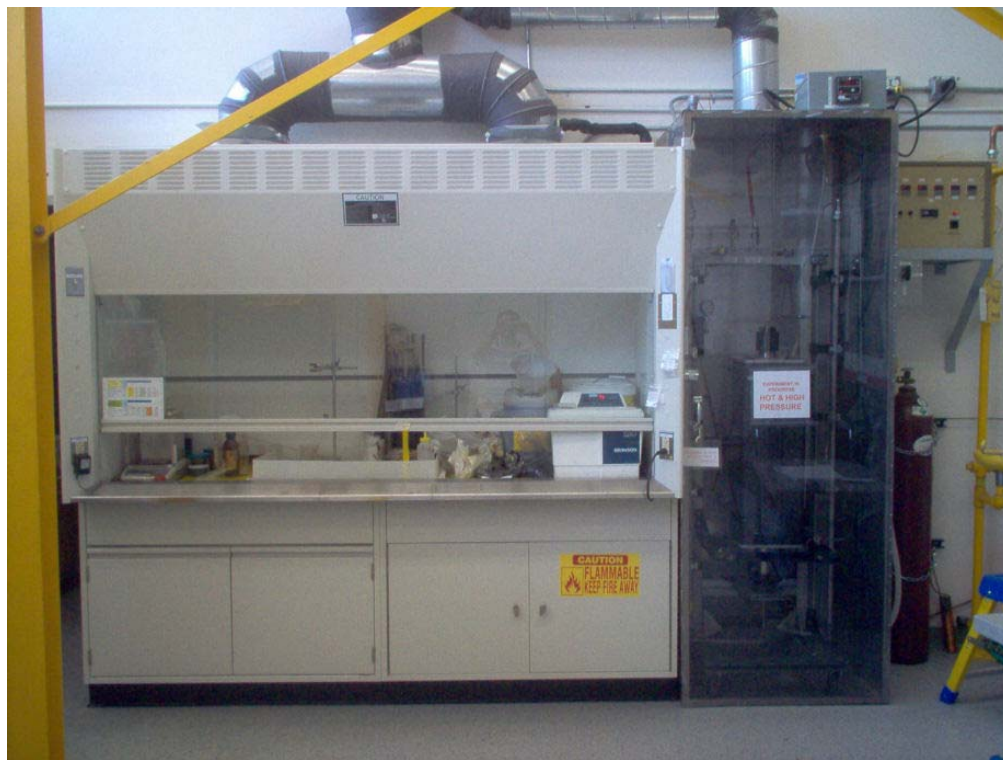
Fig. 11. Immersion corrosion test system enclosure and fume hood.
