**FABRICATION AND REPAIR OF ION SOURCE
COMPONENTS IN THE 80 keV NEUTRAL BEAM
LINES FOR DIII-D**

This is a preprint of a paper presented at the 20th
IEEE/NPSS Symposium on Fusion Engineering,
San Diego, California, October 14-17, 2003 and to be
published in *Fusion Science and Technology*.

GENERAL ATOMICS PROJECT 30033
MARCH 2004

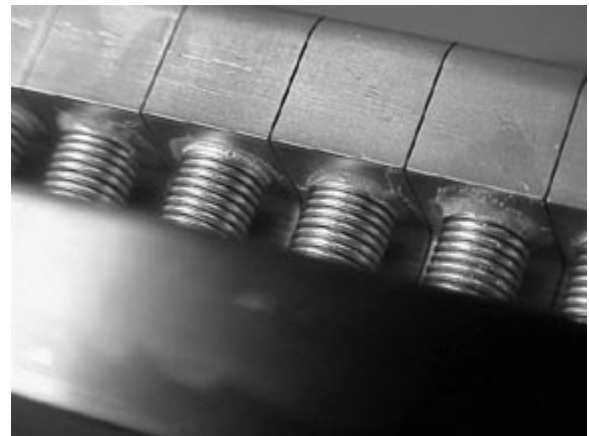
Fig. 6. Successful Palcusil-10 braze of replacement bellows into an ex-service source grid rail module.

attempted to remove the single leaking bellows from a source module and braze in a new replacement bellows using a lower temperature braze material, Palcusil-10 (59 Ag-31 Cu-10 Pd). The vacuum braze successfully produced leak-tight connections of the new bellows to the grid rail holder, but the temperature cycle tended to deplete braze material, either through diffusion or evaporation, from the joints of the original bellows. Frequently, this depletion of the original braze metal opened up one or more new leaks in previously leak-tight bellows connections. This problem was solved by replacing all 28 bellows in any source grid module requiring repair with new bellows and new braze material (Fig. 6). This change in procedure lead to successful source module repairs and currently two repaired modules have been returned to service.

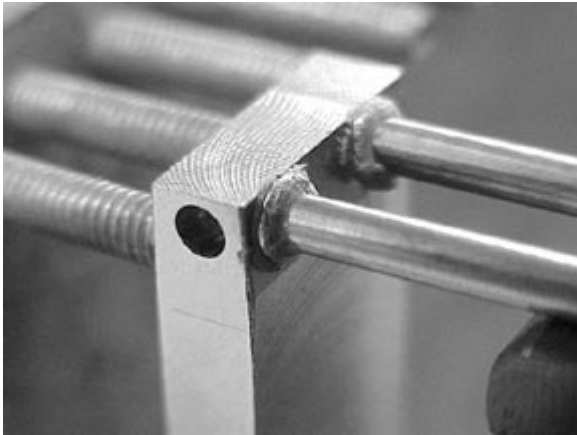
Fig. 7. Grid rail to holder joint packed with Palcusil-25 braze wire and paste prior to braze test.

Testing of the molybdenum rail to stainless steel holder joint, using Palcusil-25 braze metal is nearing completion. Fig. 7 shows the mockup holder and molybdenum rails with braze wire and paste packed on the joints just prior to brazing. Fig. 8 shows 100% braze metal penetration with acceptable fillet size on a cross-sectioned rail to holder braze test specimen. Success has been achieved on all evaluation criteria with Palcusil-25 on the rail to holder joints.
