**STRUCTURAL UPGRADE OF IN-VESSEL
CONTROL COIL ON DIII-D**

P.M. ANDERSON, A.G. KELLMAN, E.E. REIS

AUGUST 2004

GENERAL ATOMICS PROJECT 30200
AUGUST 2004

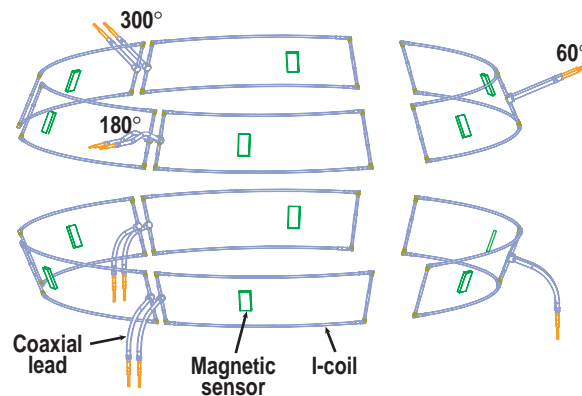
Fig. 1. Spatial location of 12 I-coils in DIII-D. Note magnetic feedback sensors and three types of coaxial leads.

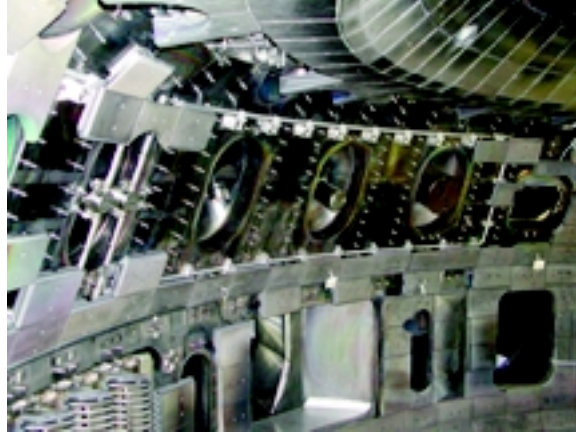
Figure 2 shows the two prototype coils that were installed in DIII-D in 2001. The single coil turn have a conductor length of 5 m and an area of 1 m². In order to minimize error fields and electromagnetic forces, the radially oriented power and cooling water feeds are coaxial and extend out from the vessel surface to near the outer edge of the toroidal field (TF) coils. The I-coils are shielded from the plasma by the graphite tiles that are shown partially installed.

Fig. 2. Installation of two prototype I-coils in DIII-D, October 2001.

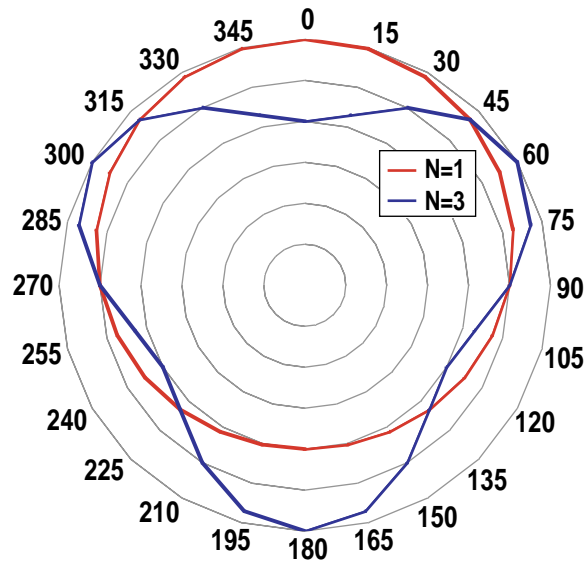
Fig. 3. Shape of N=1 and N=3 radial fields from the I-coils. Fields may be stationary or rotating. The fields from the lower and upper sets of coils can be in phase or out of phase. The magnitude of the radial field (arbitrary) is plotted versus toroidal angle.
